Capacity of Damaged Steel Columns

Douglas C. Stahl
Richard A. DeVries
Jen Deem
David Willis

Test Program

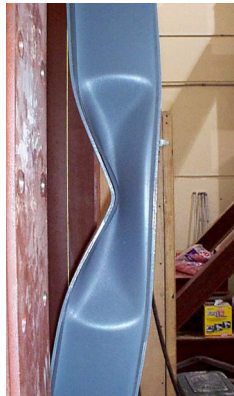
The columns were pinched in a hydraulic press to deform one half of one flange or, as shown at right, to buckle the web. When this damage was done near the base plate the

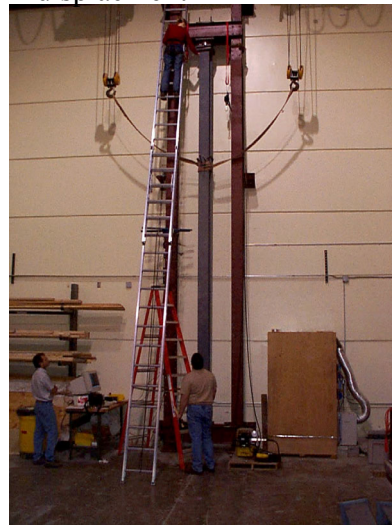
Typical top pin of test setup
